## Rebirth of a city lessons learned from post disaster reconstruction; the case study: Rofayye'

### Abstract

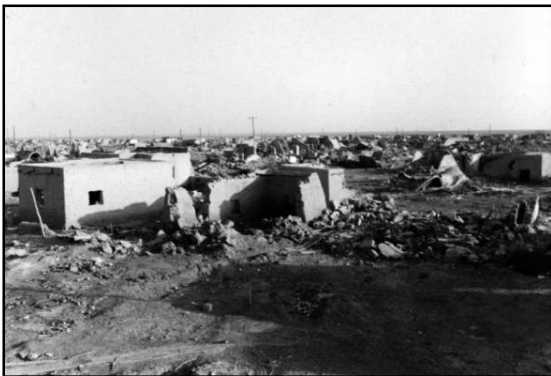
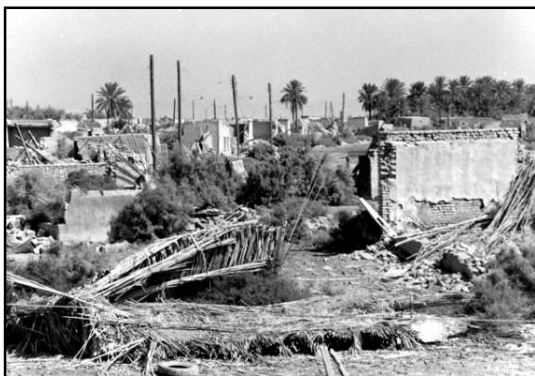
Fig. 2. The town of Rofayye' after demolishing by Iraq forces (Authors)

Rofayye' was one of the first towns occupied by Iraqi forces in September 1980. At the beginning, they destroyed the bridge between the two parts and then, demolished the southern part using heavy machineries (See Fig.2).

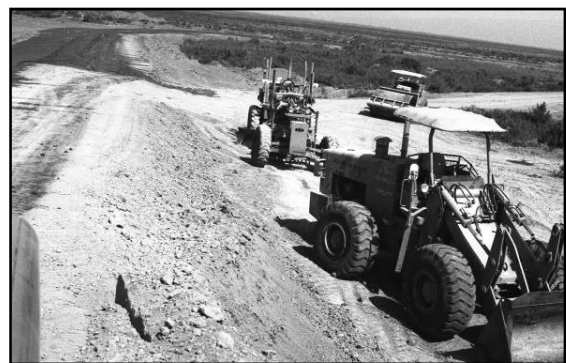
Fig. 4. Using heavy machineries to remove debris and surface the town (Authors)

debris, and about 0.5 meter deep of the land's soil were removed (See Fig.4). Consequently, the town was destroyed and surfaced, so that no mark of Rofayye' remained (See Fig.5).

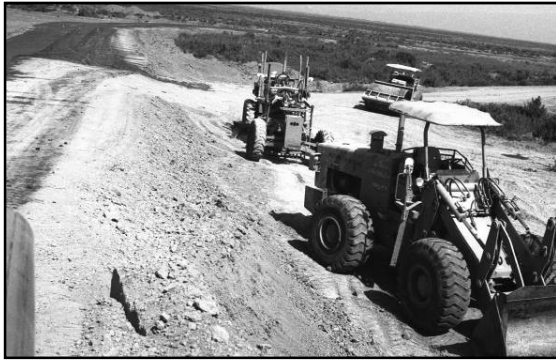
**Fig. 5.** The town of Rofayye' after surfacing by Iranian forces (Authors)

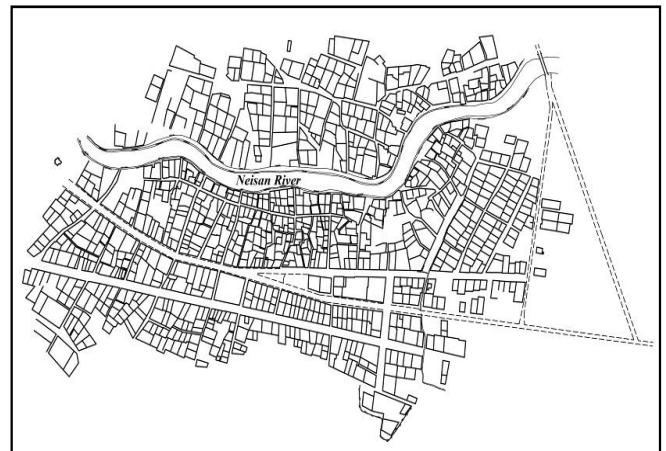
Fig. 10. Various plot sizes in old Rofayye' (Authors)

Therefore, in Rofayye's reconstruction, as mentioned, planners prepared a precise map of the affected Rofayye' and housing plots, then used the information of plots' extents and ownerships as the basis in designing the new plan. As a result, a city was designed in which there were not even two equal plots unless they had the same area in the past (See Fig. 10, 11).
